## **Brookside Village Road Evaluation Prepared for Gerald Herman**

On the morning of 8/30/2021 the Public Services Director, Public Works Manager, and Jason Reynolds from CSR Engineering conducted forensic road observations at Brookside Village based on a study session conducted on August 19<sup>th</sup> at 6:00pm.

Approximately 411 feet of Shore Drive, 302 Feet of Brook Court, and 388 feet of Brookside Lane were inspected.

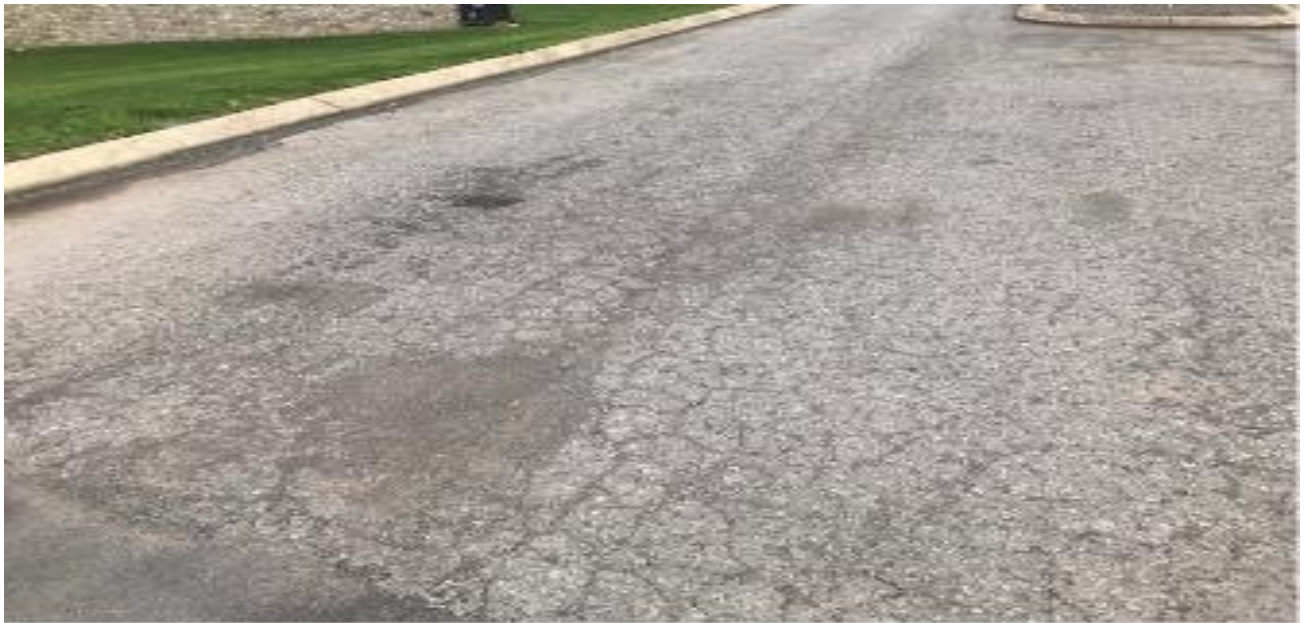
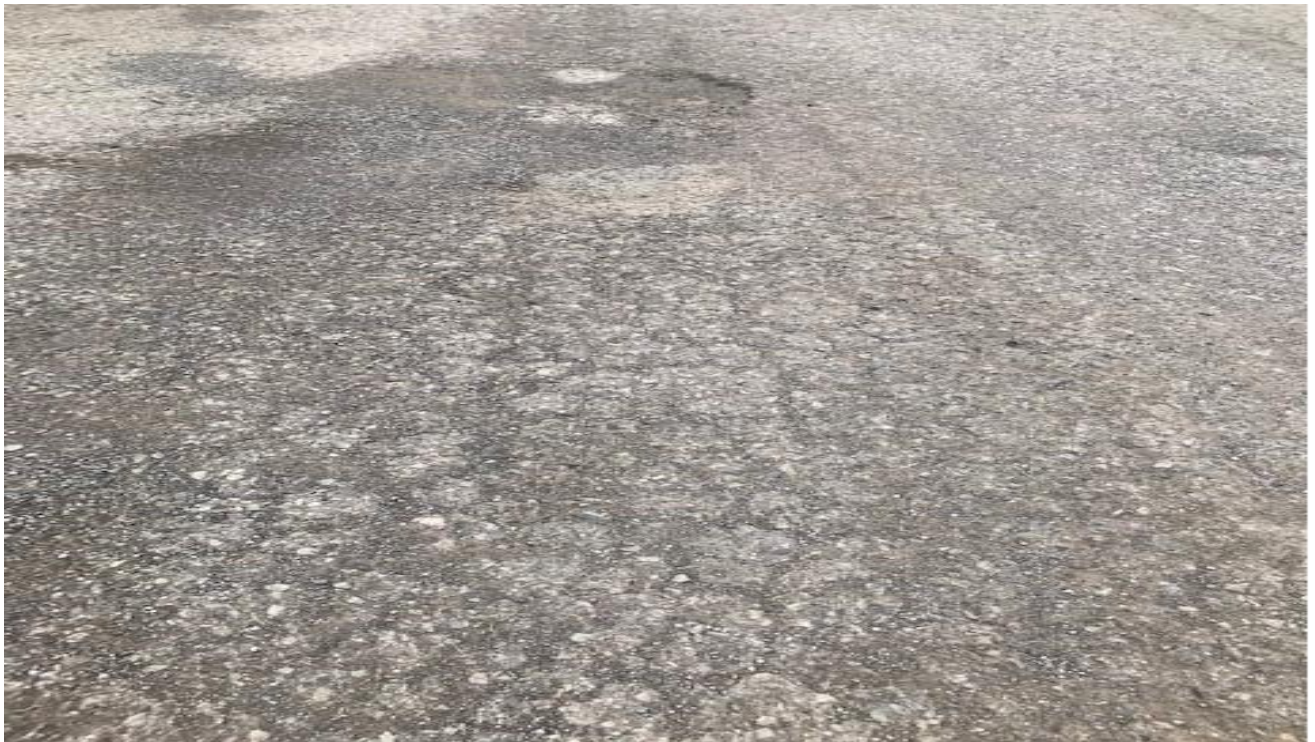
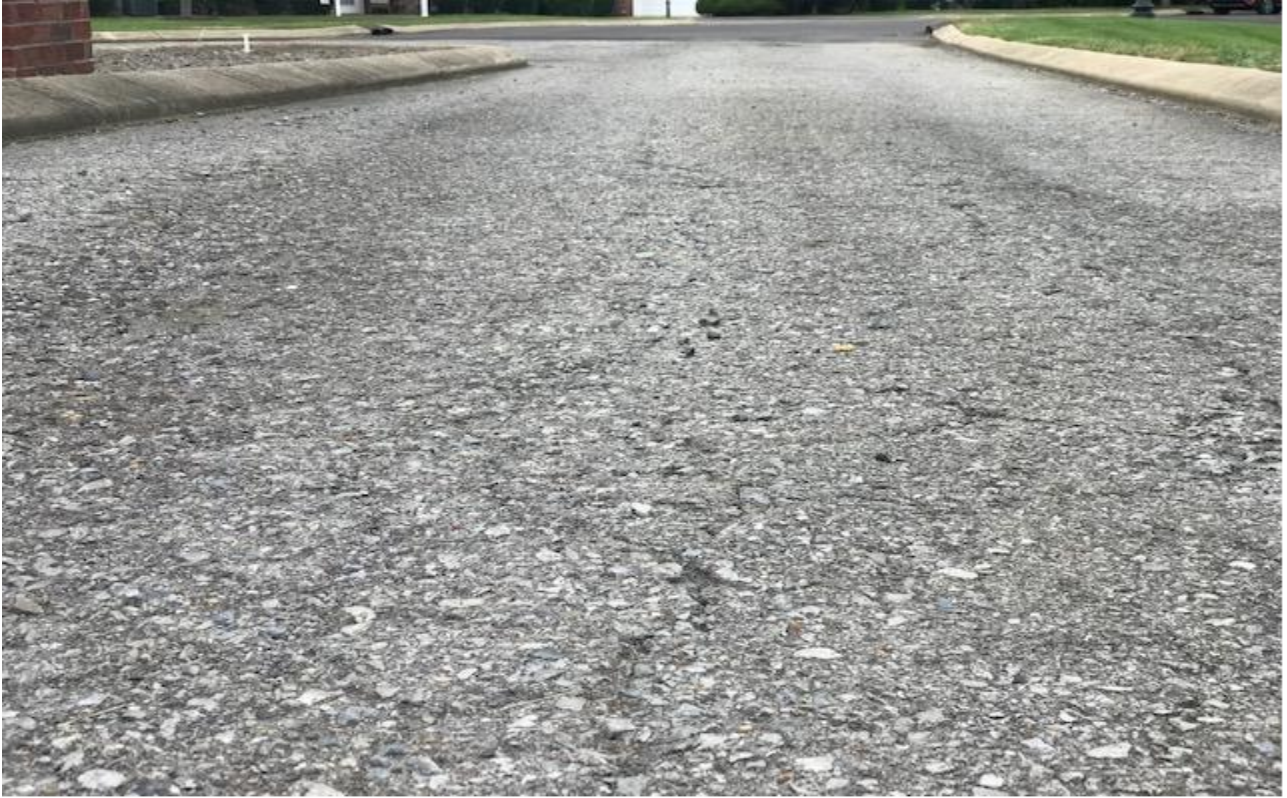
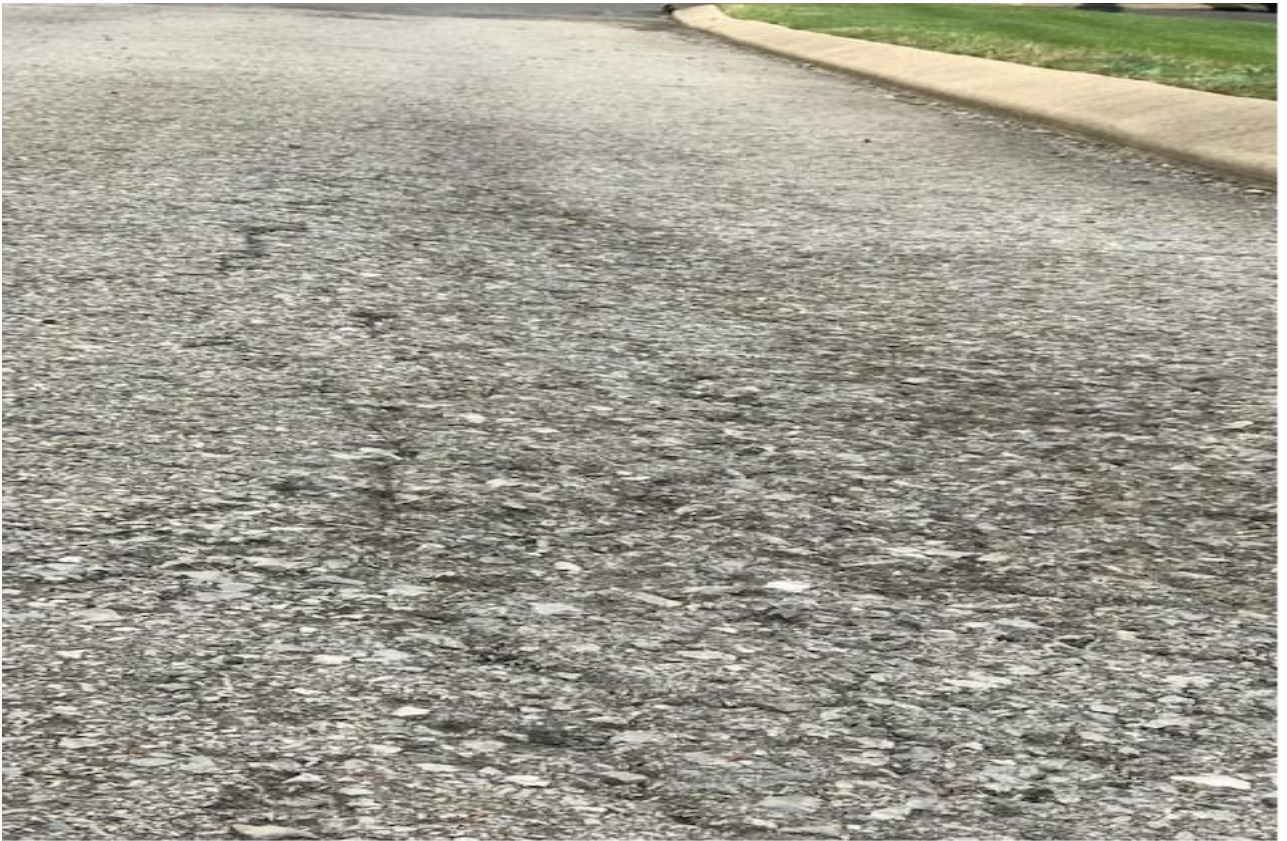
The next four (4) Pictures show Pictures of Brookside Lane:

### **Observed Problems on Brookside Lane: Pot Holes, & Rutting**

As we pulled onto Brookside Lane from Wilkinson Lane there is visible subsurface failure up to the point where the road had just been repaved. There are signs of rutting to depths of 1 inch (25 mm) and greater forming in isolated areas. Core drills will need to be performed for quality control and investigation of existing pavements. Proof Roll is not recommended in order to not further damage the road.

**Pot Holes:** Small, bowl-shaped depressions in the pavement surface that penetrate all the way through the asphalt layer down to the base course. They generally have sharp edges and vertical sides near the top of the hole. Potholes are the result of moisture infiltration and usually the end result of untreated alligator cracking. As alligator cracking becomes severe, the interconnected cracks create small chunks of pavement, which can be dislodged as vehicles drive over them. The remaining hole after the pavement chunk is dislodged is called a pothole.

**Rutting:** Ruts in asphalt pavements are channelized depressions in the wheel-tracks. Rutting results from consolidation or lateral movement of any of the pavement layers or the subgrade under traffic. It is caused by insufficient pavement thickness; lack of compaction of the asphalt, stone base or soil; weak asphalt mixes; or moisture infiltration.

**FIX:** Full depth replacement patch

**FIX:** If rutting is minor or if it has stabilized, the depressions can be filled and overlaid. If the deformations are severe, the rutted area should be removed and replaced with suitable material.

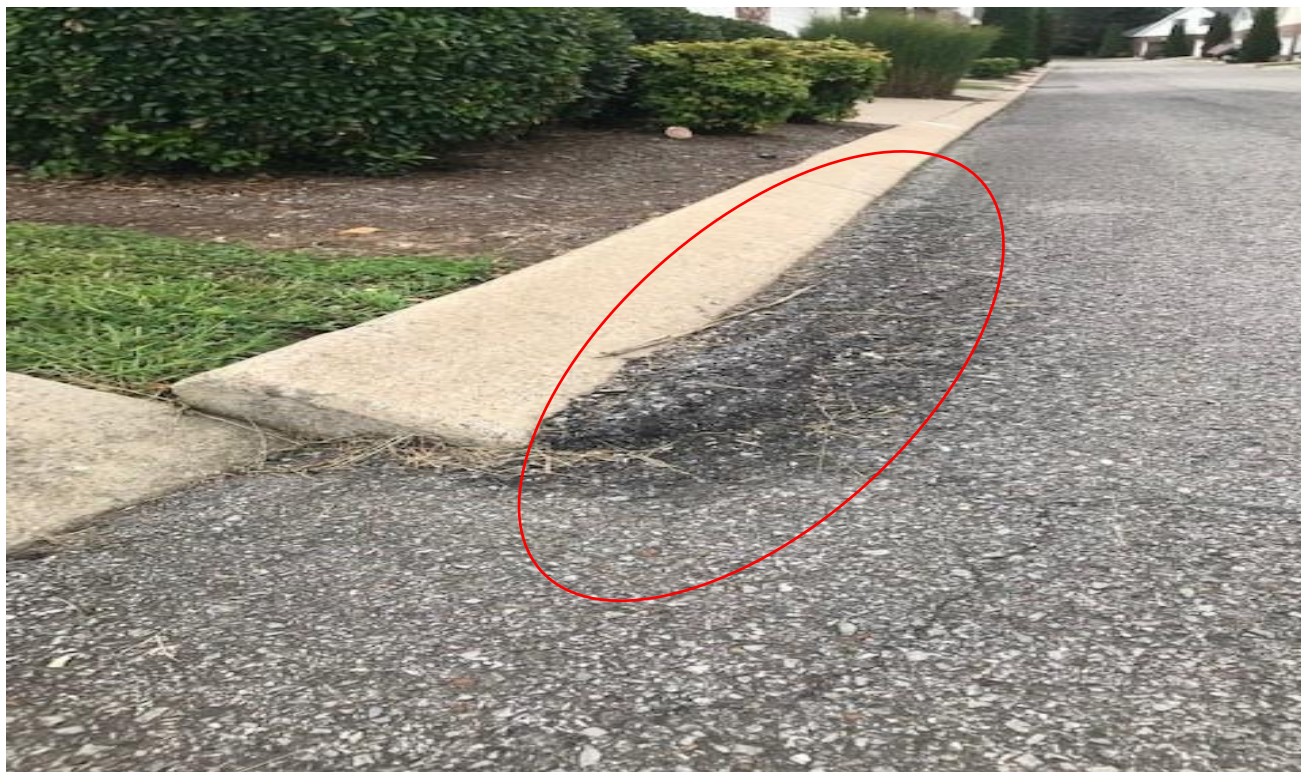
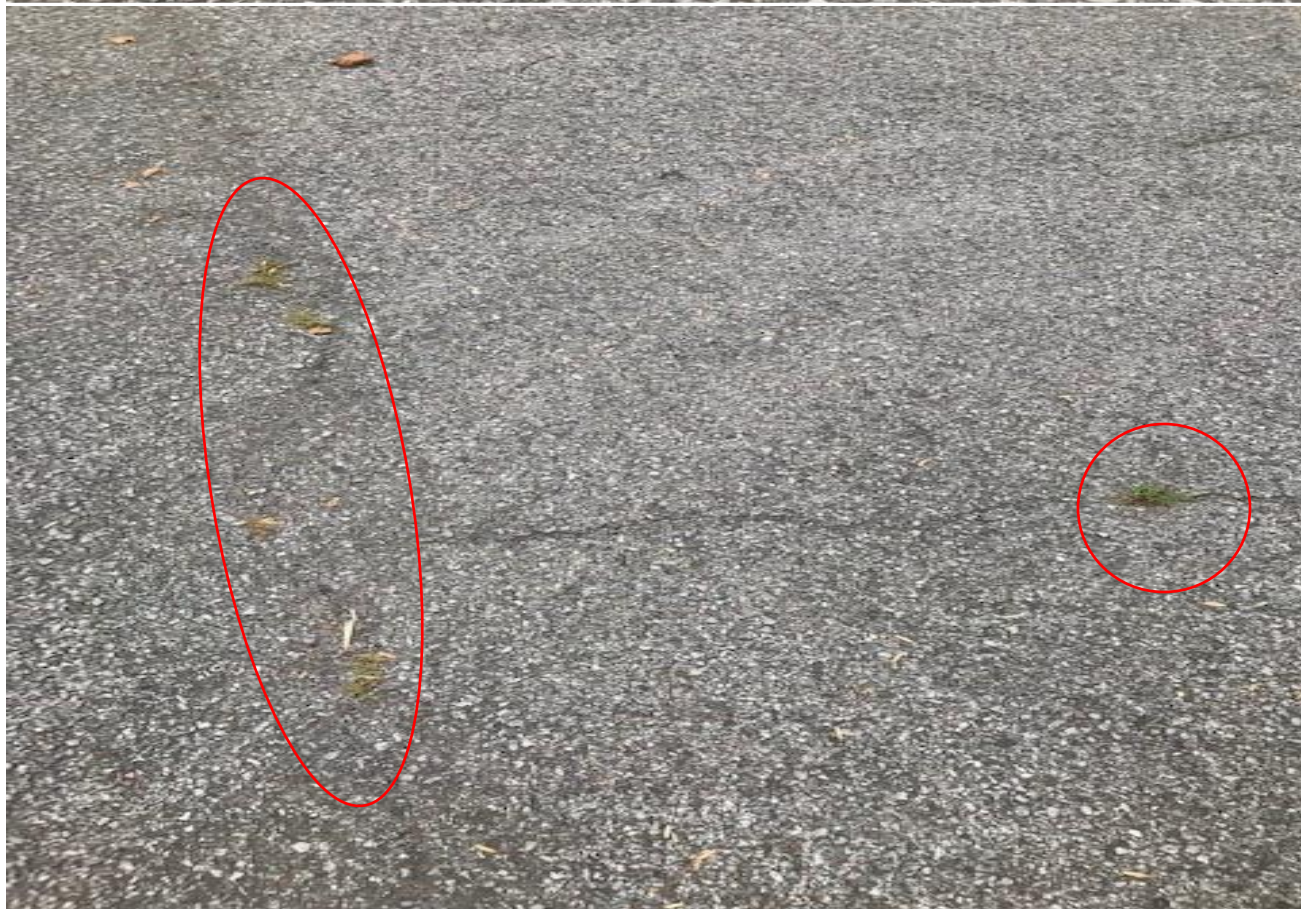
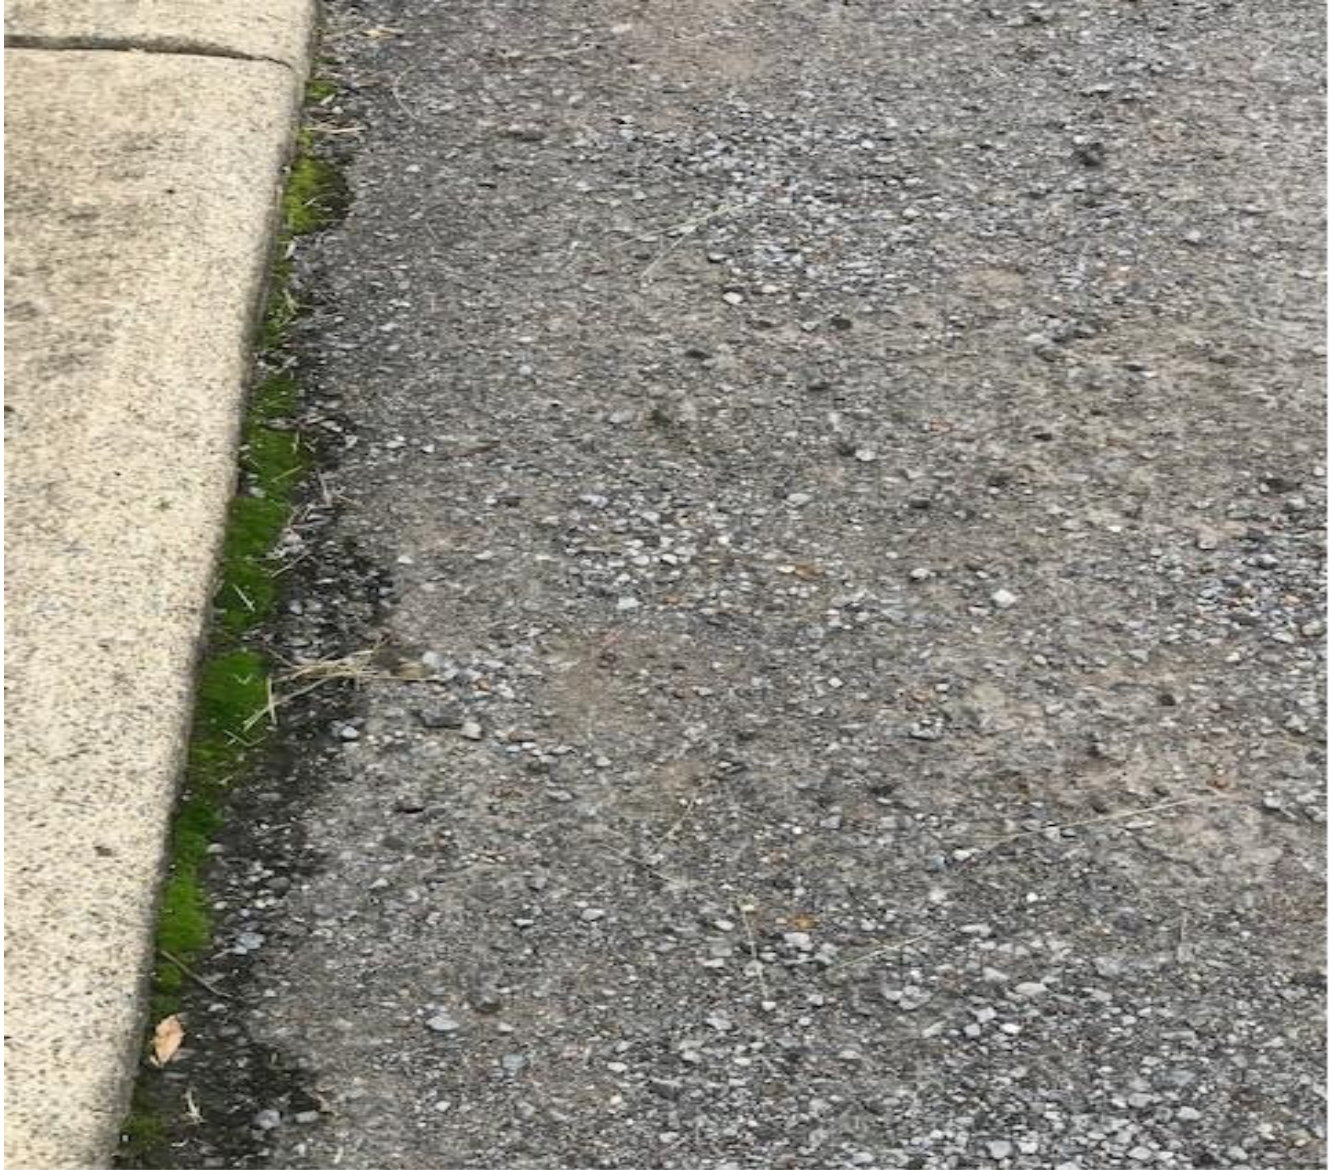
The next three (3) pictures visually illustrate Shore Drive

### **Observed Problems on Shore Drive: Alligator Cracking & Shoving**

**Alligator cracking:** Is a load associated structural failure. The failure can be due to weakness in the surface, base or sub grade; a surface or base that is too thin; poor drainage or the combination of all three. It often starts in the wheel path as longitudinal cracking and ends up as alligator cracking after severe distress. The cul-de-sac does meet the turn radius for the fire department.

**Shoving:** Shoving is the formation of ripples across a pavement. This characteristic shape is why this type of distress is sometimes called wash-boarding. Shoving occurs at locations having severe horizontal stresses, such as intersections. It is typically caused by: excess asphalt; too much fine aggregate; rounded aggregate; too soft an asphalt; or a weak granular base.

**Grass** – Poorly maintained roads will often have grass growing up through the cracks. Cleaning the cracks should be standard practice before sealing them. Use a heat lance to burn out the crack and/or blow out the cracks depending on the severity of the problem.

Damage due to moisture in pavements usually initiates at or near the bottom of the asphalt bound layers or at interfaces between layers. Advanced moisture damage in pavements can lead to rutting, shoving, corrugations, fatigue cracking, raveling, flushing, and pot holes.

**FIX:** Because a structural failure is taking place the only possible solution to alligator cracking is to perform a full-depth patch.

**FIX:** Partial or full depth patch

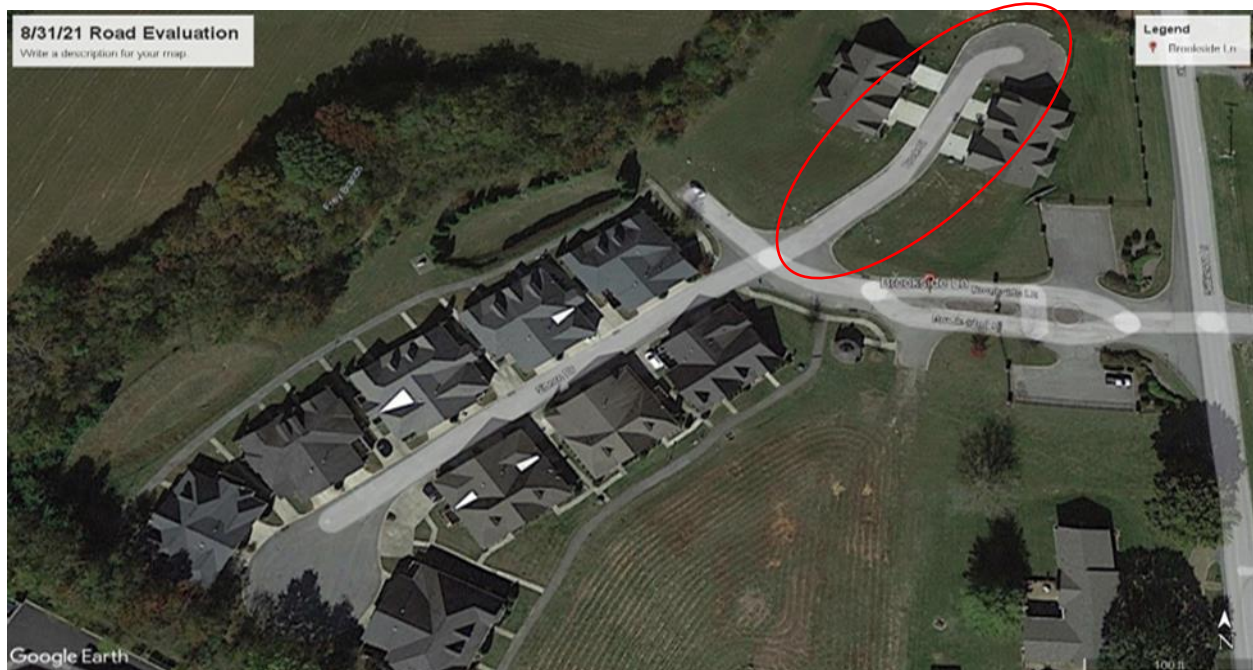
### **Observed Problems on Brook Court: Recently Paved by a company based out of Bowling Green**

After contacting the paving company and asking a few questions, it was determined that in some places 1 7/8 to 2 inches of asphalt was laid because of the poor uneven road conditions. As per the contractor, the road should last 5 years with no issues. Outside of conducting a road core, it will be impossible to determine the integrity below the new asphalt. We are awaiting the specifications of the asphalt mix used and tonnage to pave Brook Court.

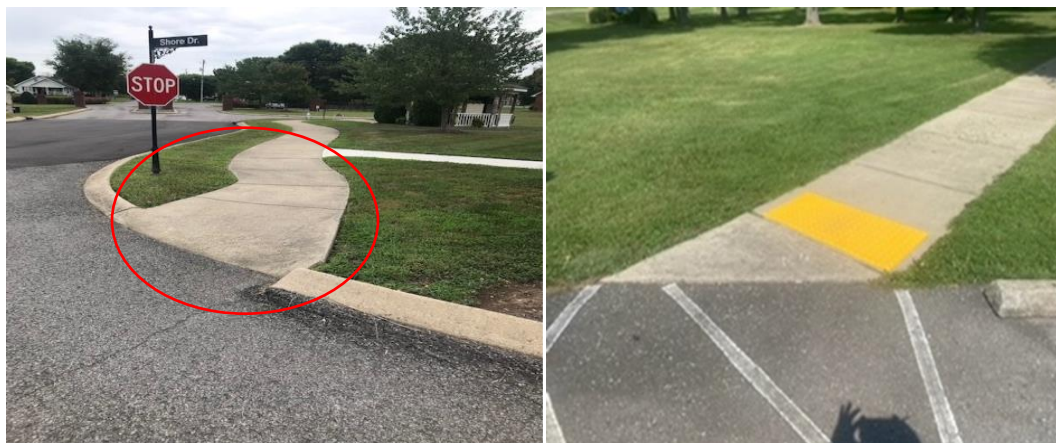
Other observations were noticed: The sidewalks do not meet ADA compliance.

We would need to install ADA Compliant Truncated Dome Mats. Please see photo on right from another development.
