City of White House, Tennessee
American with Disabilities Act
Facilities Inventory Self-Evaluation and Transition Plan

CSR
Engineering

November 30, 2019

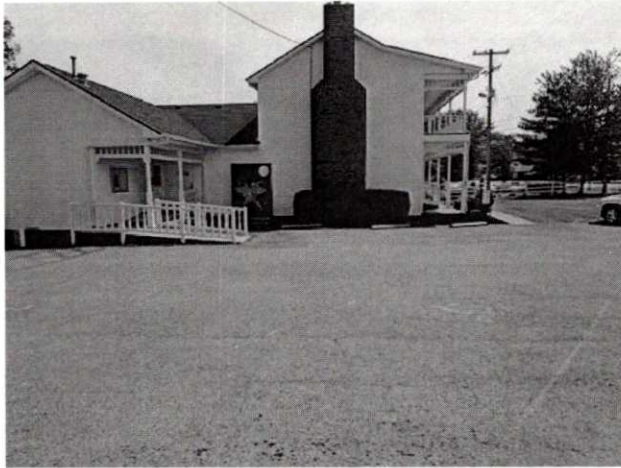
WH Inn Museum-No Signs, Faded Paint, Location

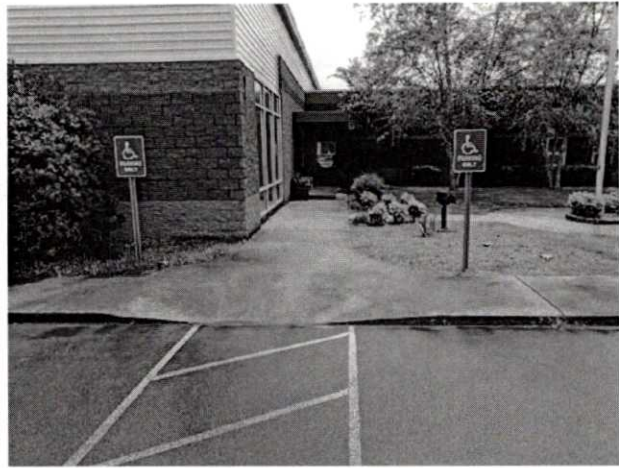
Fire Station #2-No Van Accessible signage (example)

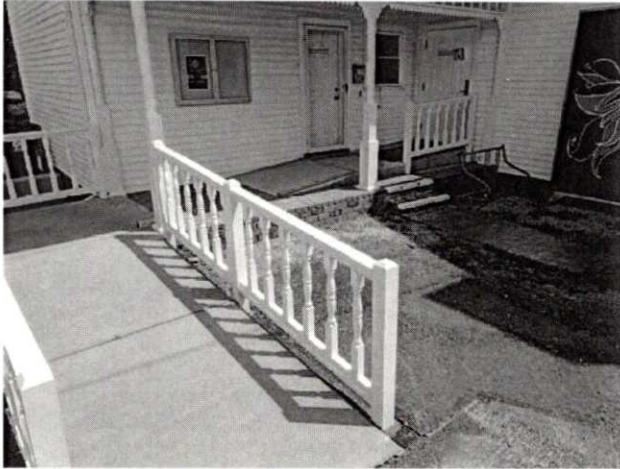
WH Inn Museum-Handrail Non-Compliant

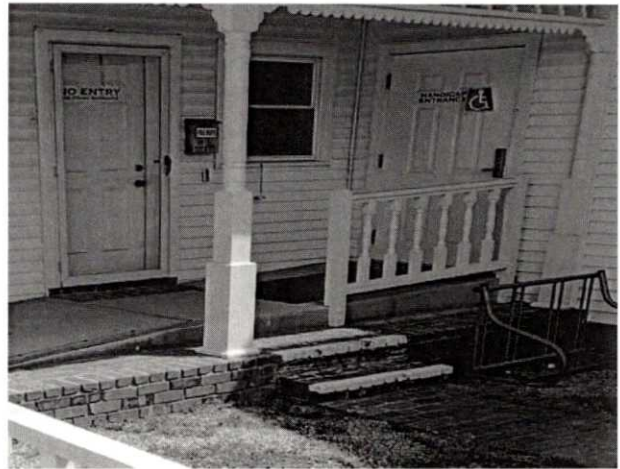
WH Inn Museum-No Entry Landing, Proper Signage

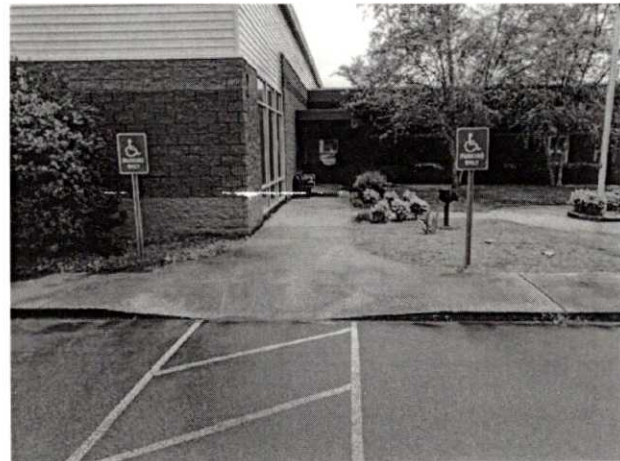
Police Department-No Ramp Detectable Surface Warning

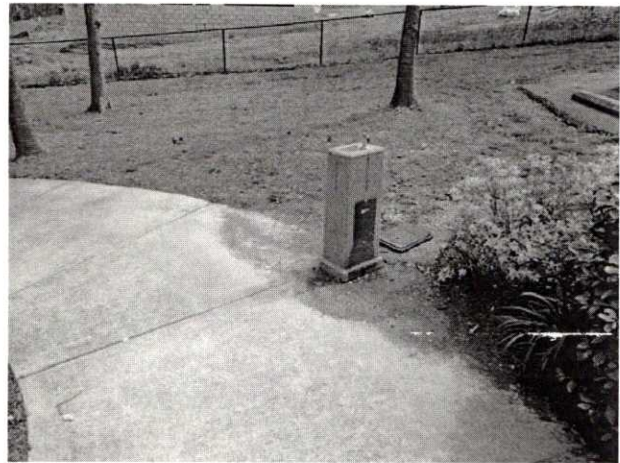
Veterans Memorial Trailhead-Non Compliant Fountain

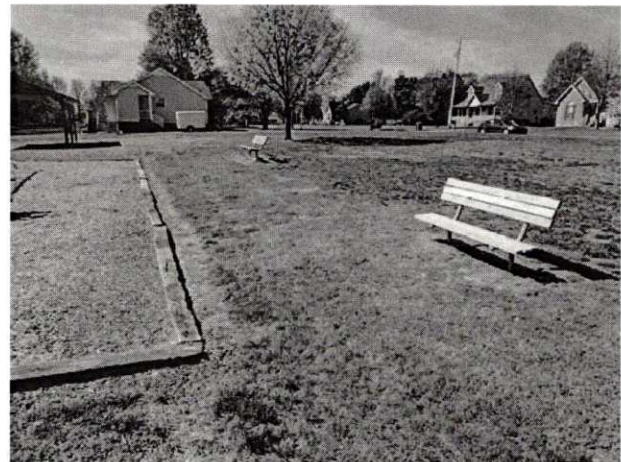
North Wood-Non Accessible Bench

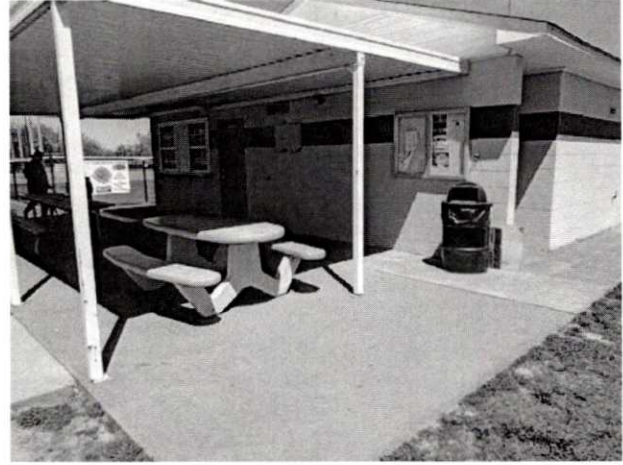
WH Mun. Park Concessions-Table & Window Non-Compliant

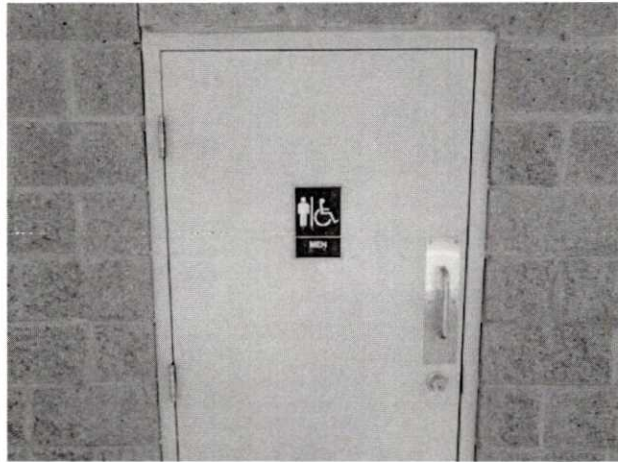
WH Mun. Park-Field 5 Restrooms Signage

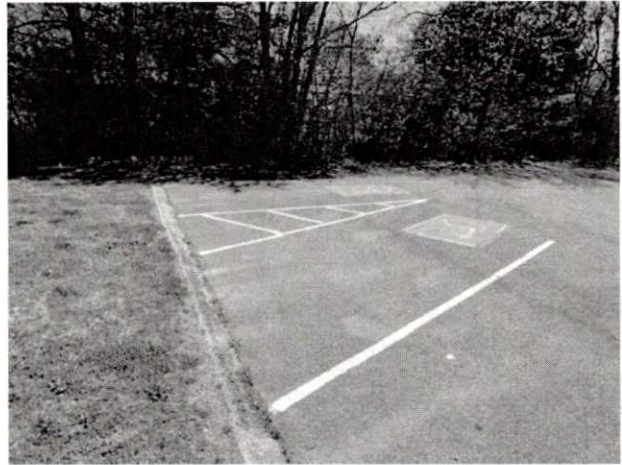
**WH Mun. Park- Basketball Court
No Signage or Ramp Access**

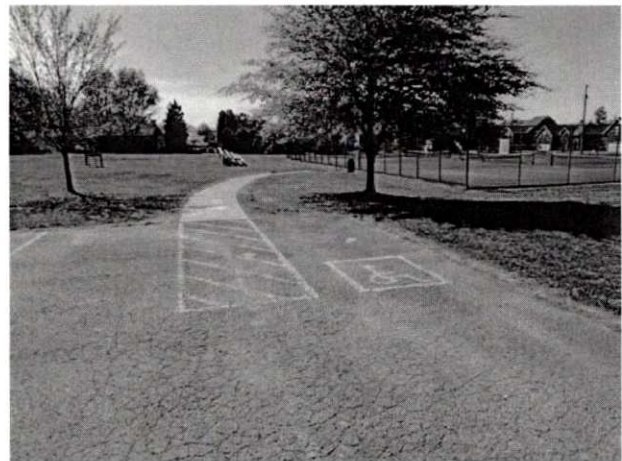
WH Mun. Park-Tennis; No Signage, Faded Paint

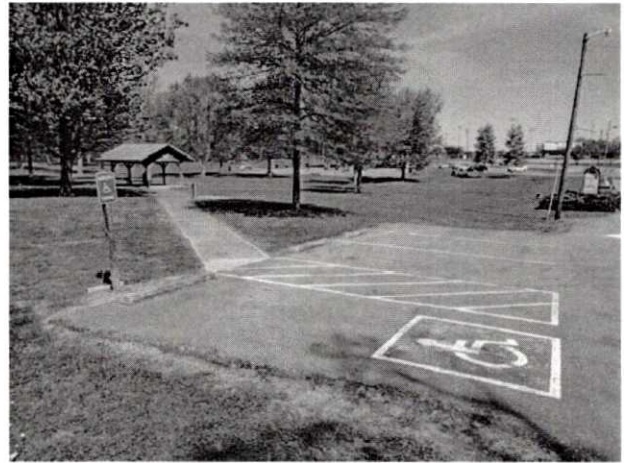
WH Mun. Park-Ramp to Pavilion #1, No Detectable Warning

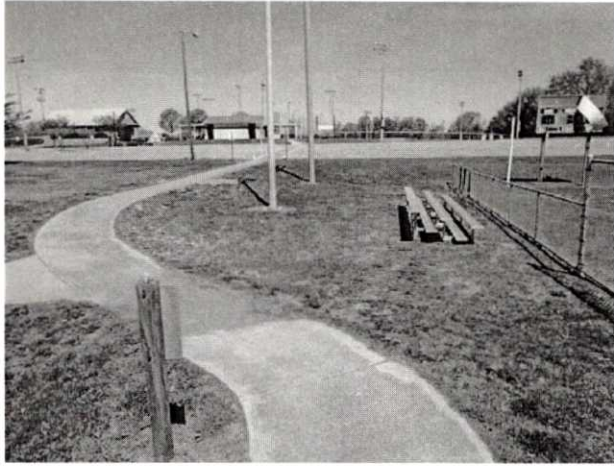
WH Mun. Park-Field 1-4 Sidwalk, No Access to Bleachers

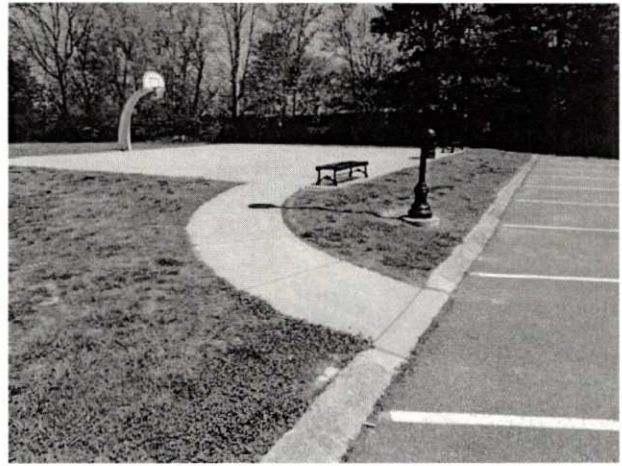
WH Mun. Park BBall Court #1-Non Compliant Ramp

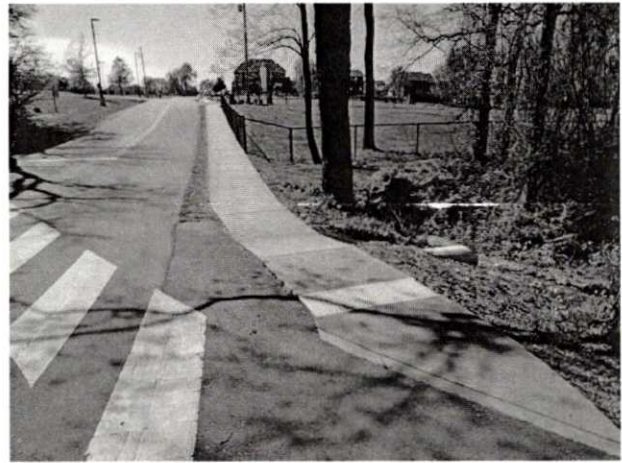
WH Mun. Park-Path to Dog Park, Exceeds Slope-Grade

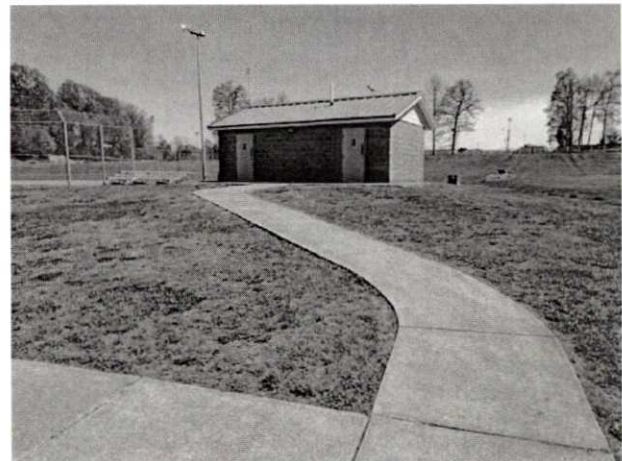
WH Mun. Park-Path to Restrooms Exceeds Slopes

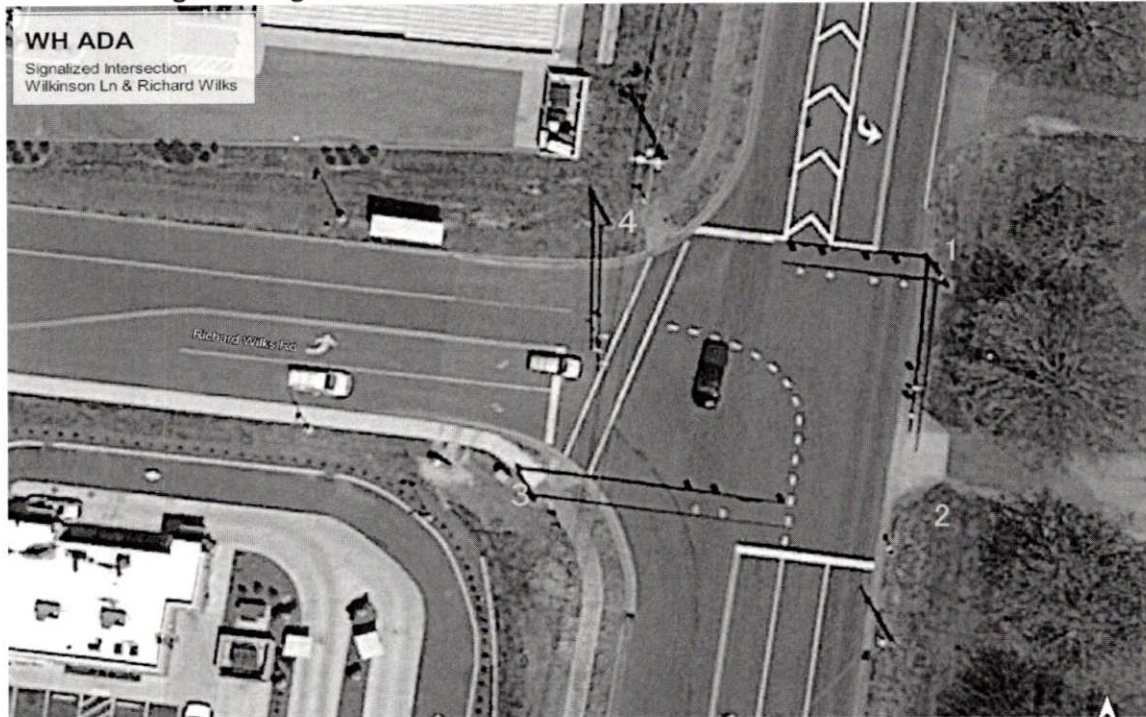
Figure 3: Signalized Intersection at Wilkinson Lane & Richard Wilks

Pedestrian signals and crossings at the Wilkinson Lane and Richard Wilks intersection (#3) have been installed with future improvements in mind. For example, new signal poles and equipment have been installed at all four corners, however, presently there is only one crossing available.

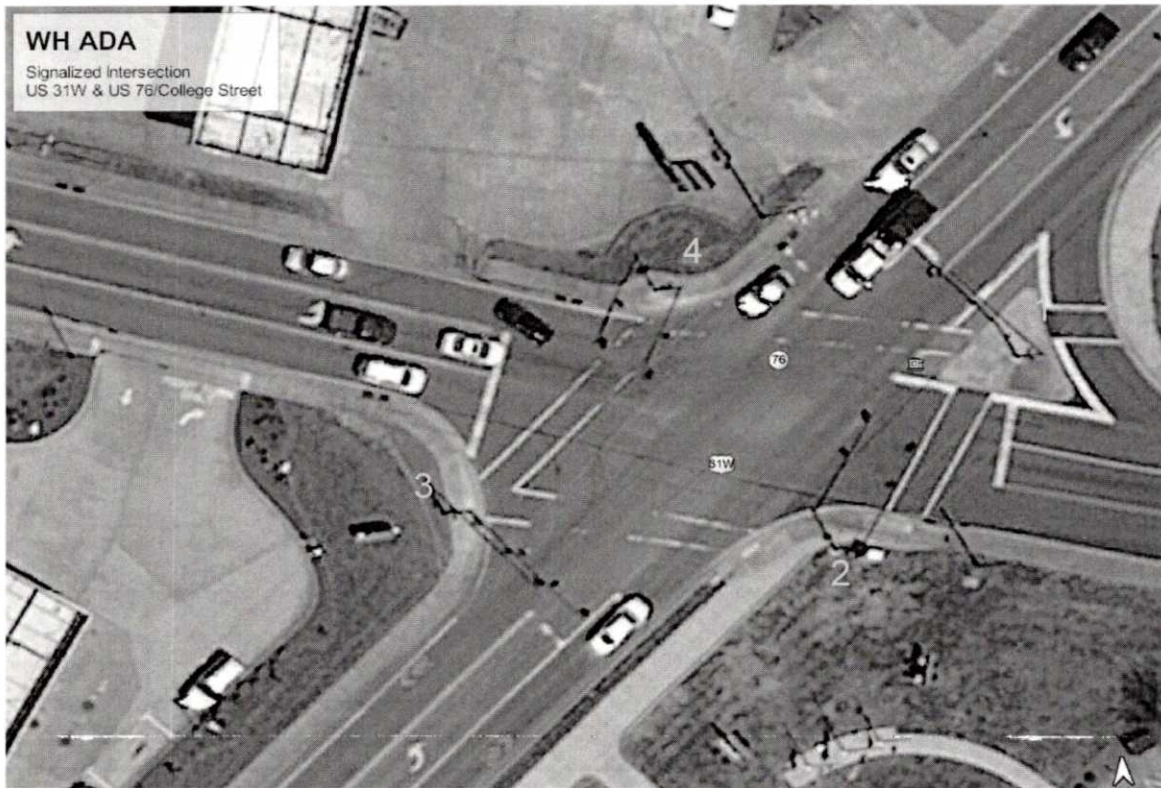
Figure 6: Signalized Intersection at US 31W & SR 76/College

The Intersection (#6) at US 31W and SR 76 represents a major pedestrian crossing corridor. Each of the four corners has two crossings with pole mounted pedestrian signals. It is anticipated that the ongoing improvements along SR 76 will incorporate this intersection. The photos and table below present current observations and findings.

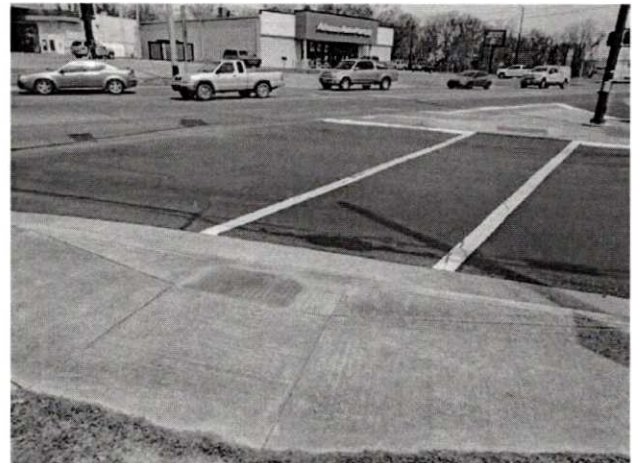
US 31W/SR 76 Crossing 2 Facing 1

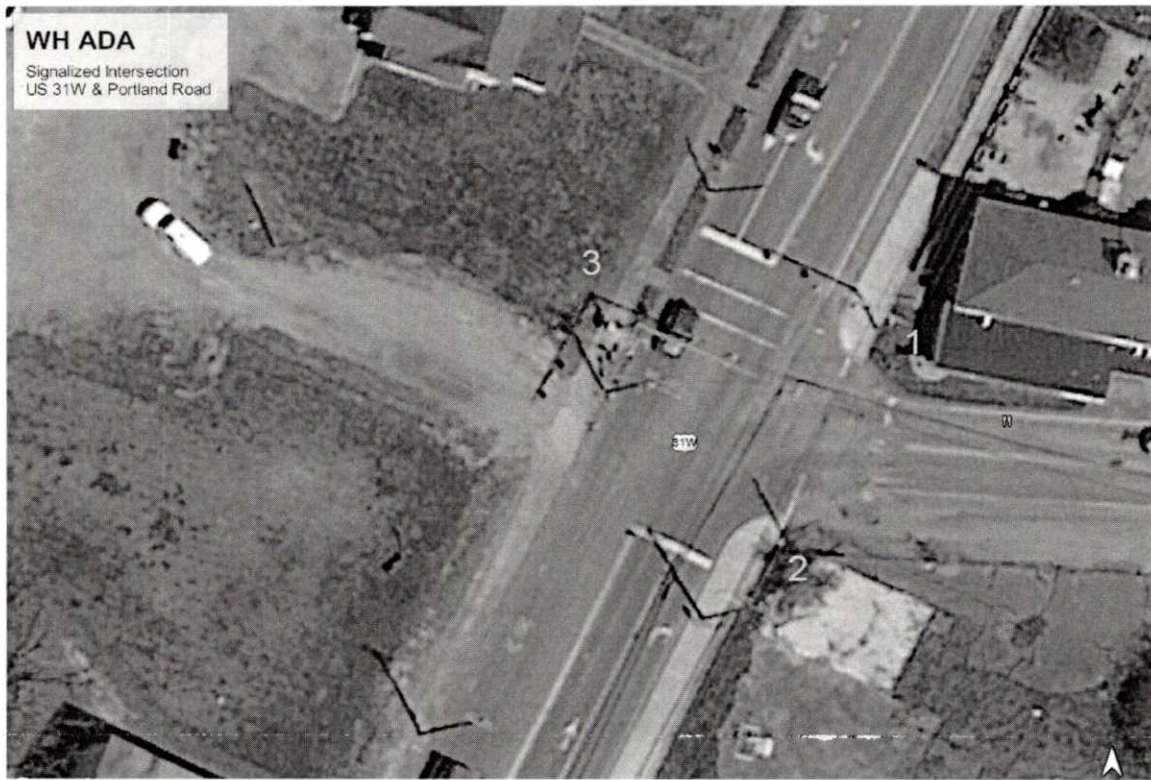
Figure 7: Signalized Intersection at US 31W & Portland Road

The intersection (#7) at US 31W and Portland Road is in need of improvements and upgrades. The signal pole at corner 1 is located in the pedestrian path, signals are not working, push buttons are not in compliance, signs direct to wrong direction and crosswalk paint is faded. The photos and table below present current observations and findings.

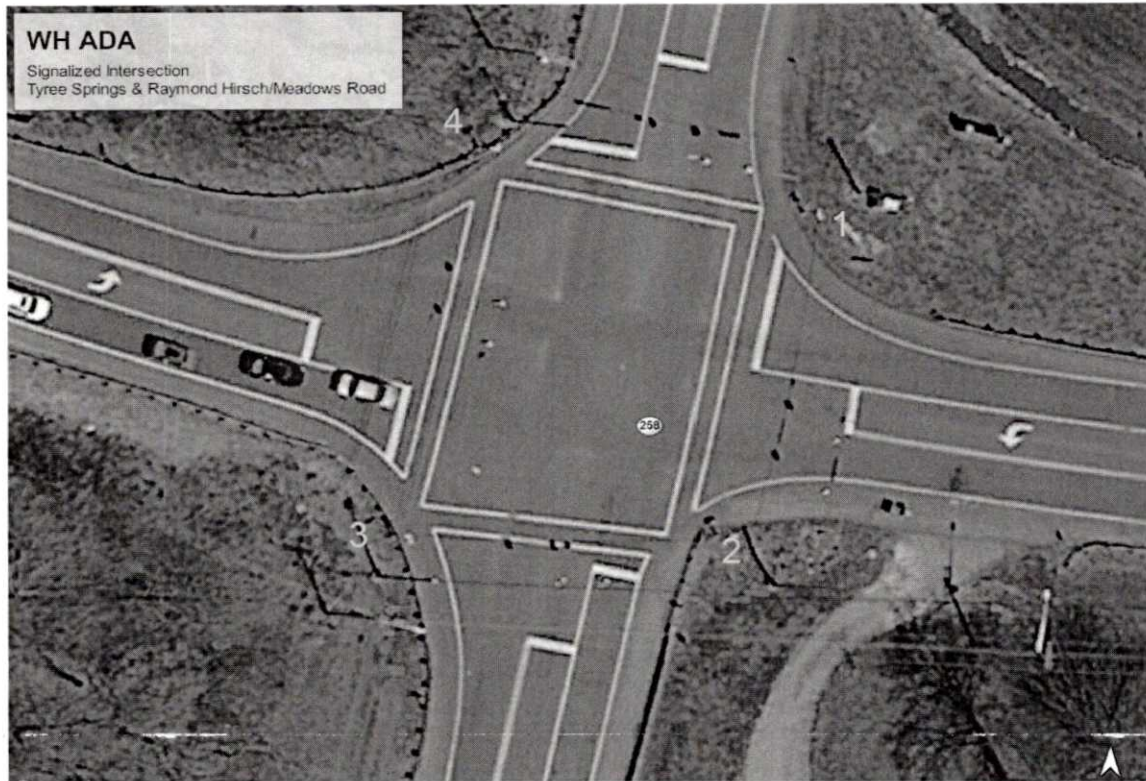
Figure 8: Signalized Intersection at Raymond Hirsch & Tyree Springs

The intersection (#8) at Raymond Hirsch and Tyree Springs Road in need of improvements and upgrades. Signal crossing poles are located on all four corners, however the intersection has not been improved with sidewalks and accessible pathways. It is assumed that the crosswalks and signals are for students walking to nearby White House High School and to control School traffic. There are no sidewalks, no clear path to pushbuttons, out of compliance push buttons, non-working crossing signs and a guardrail impedance. The photos and table below present current observations and findings.

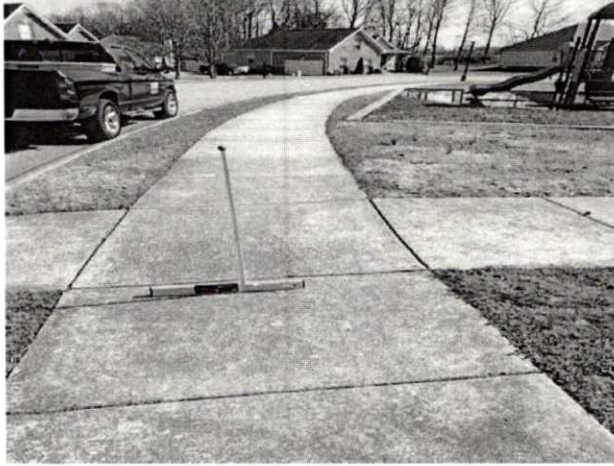
Foster Drive-Example Non-Compliant Cross Slope

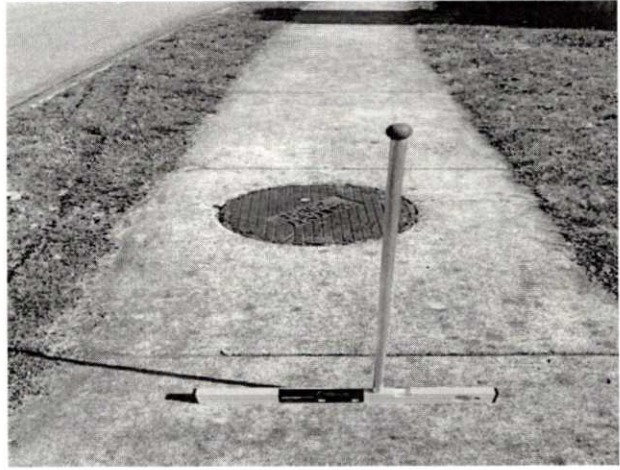
Foster Drive-Change in level Sewer Lid

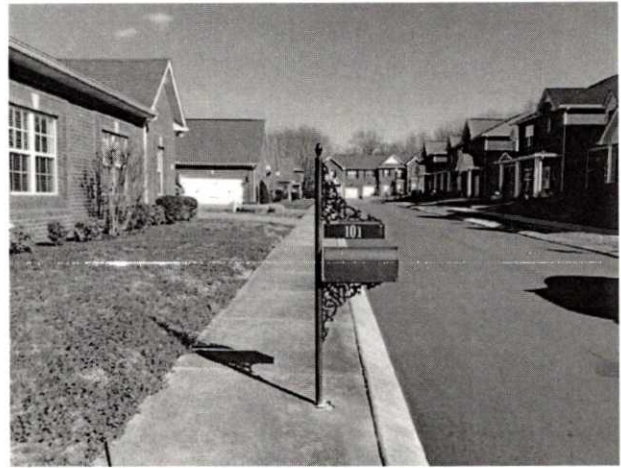
Abbey Lane-Typical Mailbox in Path

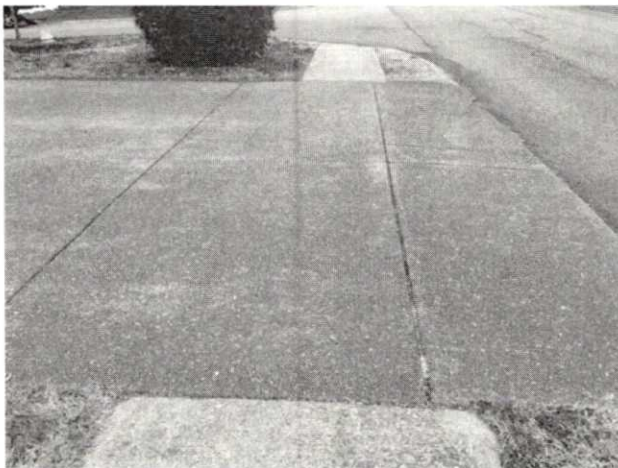
Apache Trail-Typical Driveway Expansion Joint Discontinuity

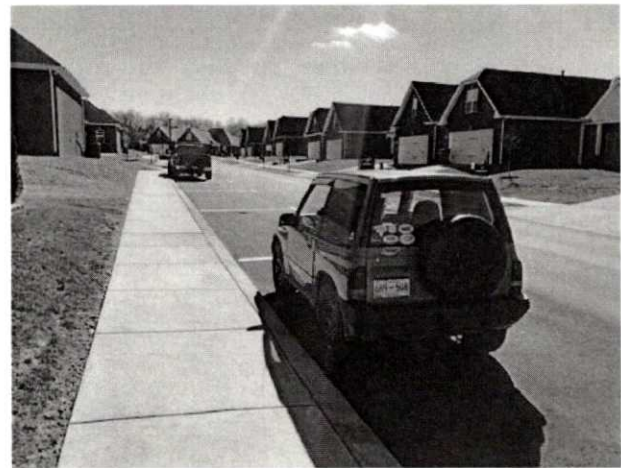
Indian Ridge Street Parking-No Accessible Spaces or Ramp

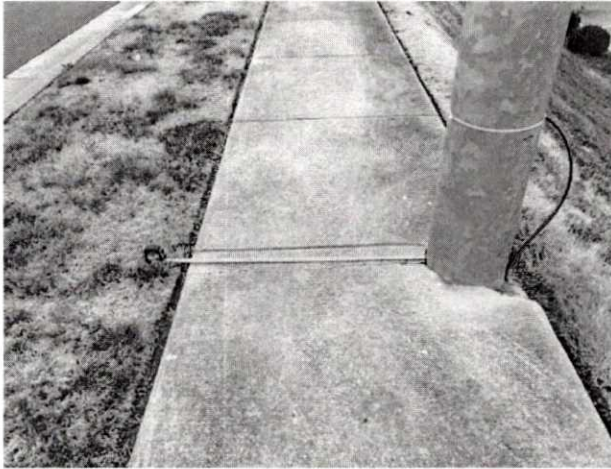
Wilkinson Lane-Utility Pole Obstruction

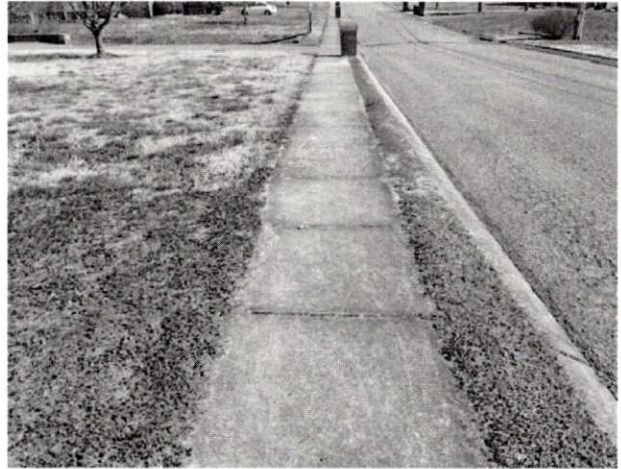
Blueberry Street-Typical no Passing Areas

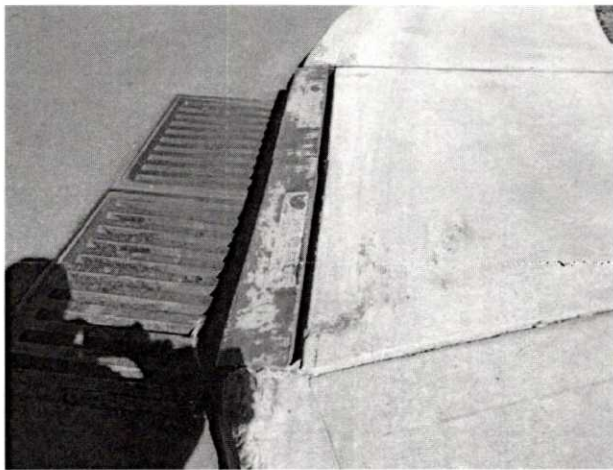
Hester Drive-Storm Grate Separated from Sidewalk

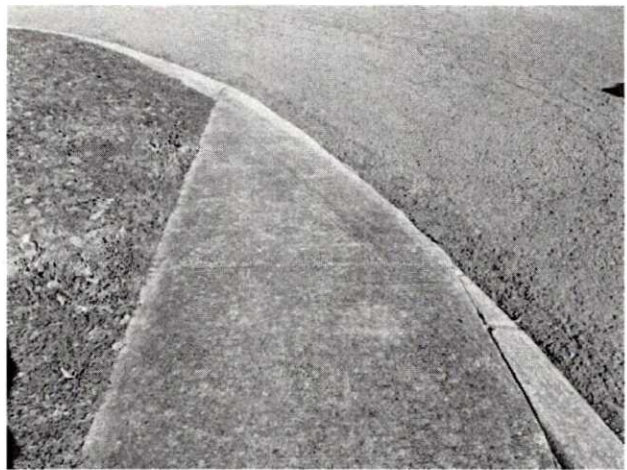
Westchester Drive-Ramp Not Compliant

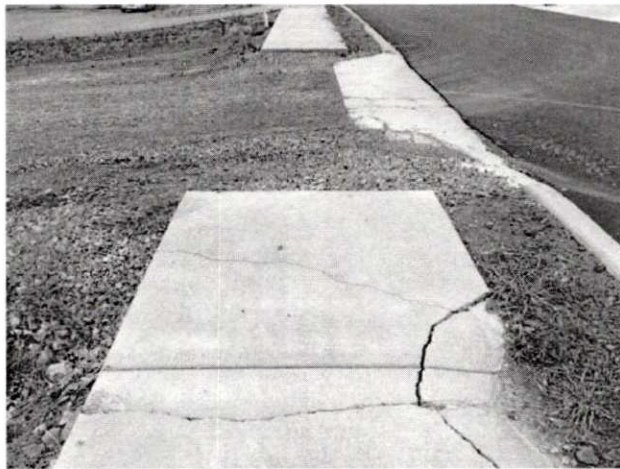
Renee Court-Segment Missing

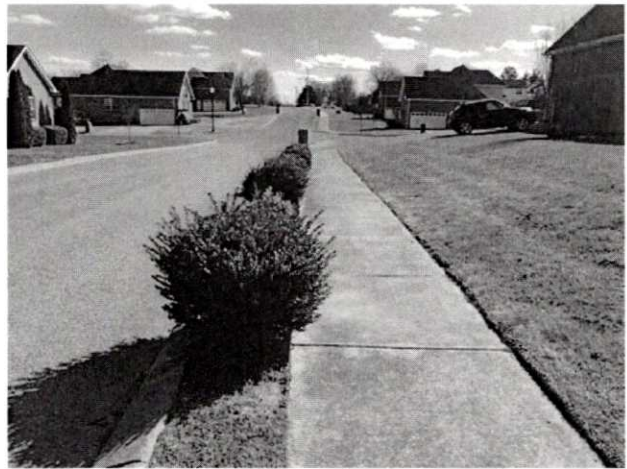
Chapman Drive-Vegetation Overgrowth

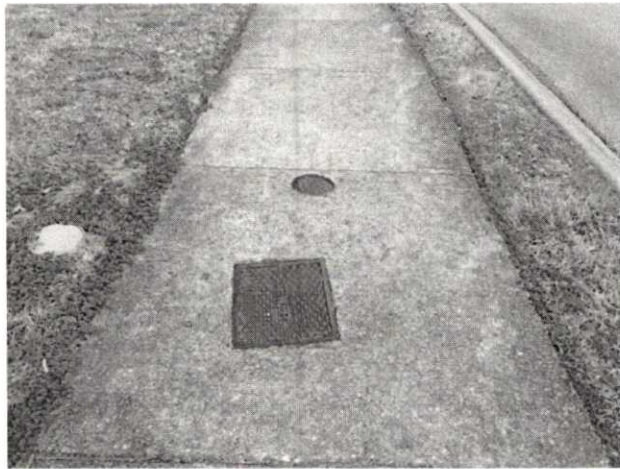
Larkspur Drive-Electrical/Water Covers

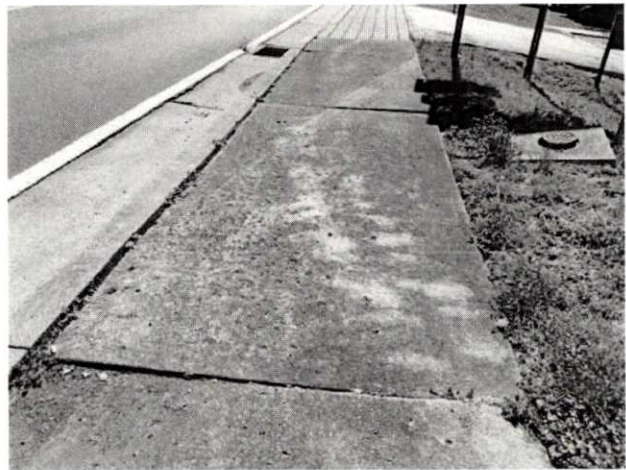
Raymond Hirsch Pkwy-Segment Out of Alignment

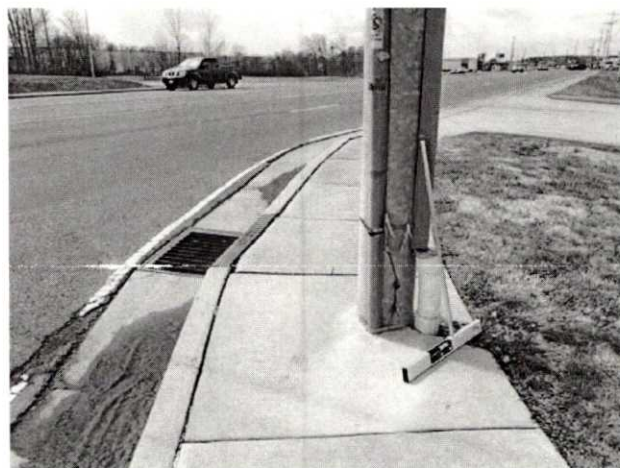
SR 76/Lone Oak-Utility Pole Obstruction

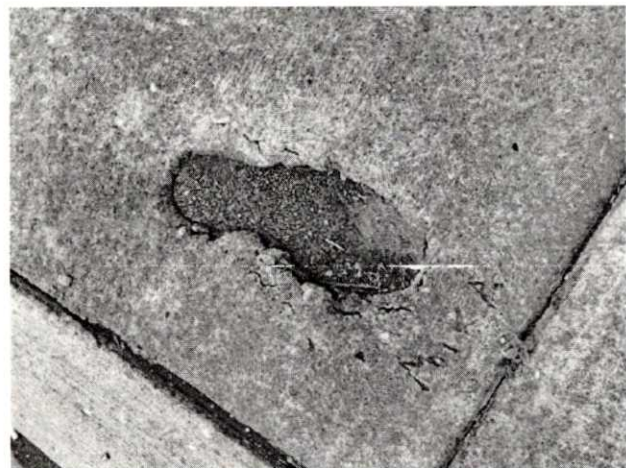
SR 76/Byrum-Footprint in Pathway
