## **Brookside Village Road Evaluation Prepared for Gerald Herman**

On the morning of 8/30/2021 the Public Services Director, Public Works Manager, and Jason Reynolds from CSR Engineering conducted forensic road observations at Brookside Village based on a study session conducted on August 19<sup>th</sup> at 6:00pm.

Approximately 411 feet of Shore Drive, 302 Feet of Brook Court, and 388 feet of Brookside Lane were inspected.

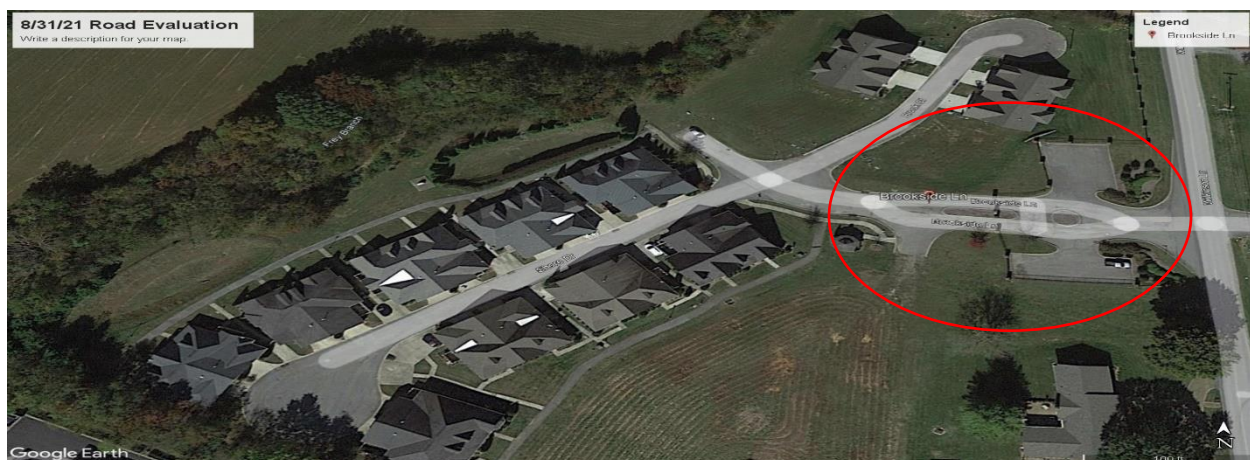
As we pulled onto Brookside Lane from Wilkinson Lane there is visible subsurface failure up to the point where the road had just been repaved. There are signs of rutting to depths of 1 inch (25 mm) and greater forming in isolated areas. Core drills will need to be performed for quality control and investigation of existing pavements. Proof Roll is not recommended in order to not further damage the road.

**Pot Holes:** Small, bowl-shaped depressions in the pavement surface that penetrate all the way through the asphalt layer down to the base course. They generally have sharp edges and vertical sides near the top of the hole. Potholes are the result of moisture infiltration and usually the end result of untreated alligator cracking. As alligator cracking becomes severe, the interconnected cracks create small chunks of pavement, which can be dislodged as vehicles drive over them. The remaining hole after the pavement chunk is dislodged is called a pothole.

**Rutting:** Ruts in asphalt pavements are channelized depressions in the wheel-tracks. Rutting results from consolidation or lateral movement of any of the pavement layers or the subgrade under traffic. It is caused by insufficient pavement thickness; lack of compaction of the asphalt, stone base or soil; weak asphalt mixes; or moisture infiltration.

**FIX:** Full depth replacement patch

**FIX:** If rutting is minor or if it has stabilized, the depressions can be filled and overlaid. If the deformations are severe, the rutted area should be removed and replaced with suitable material.

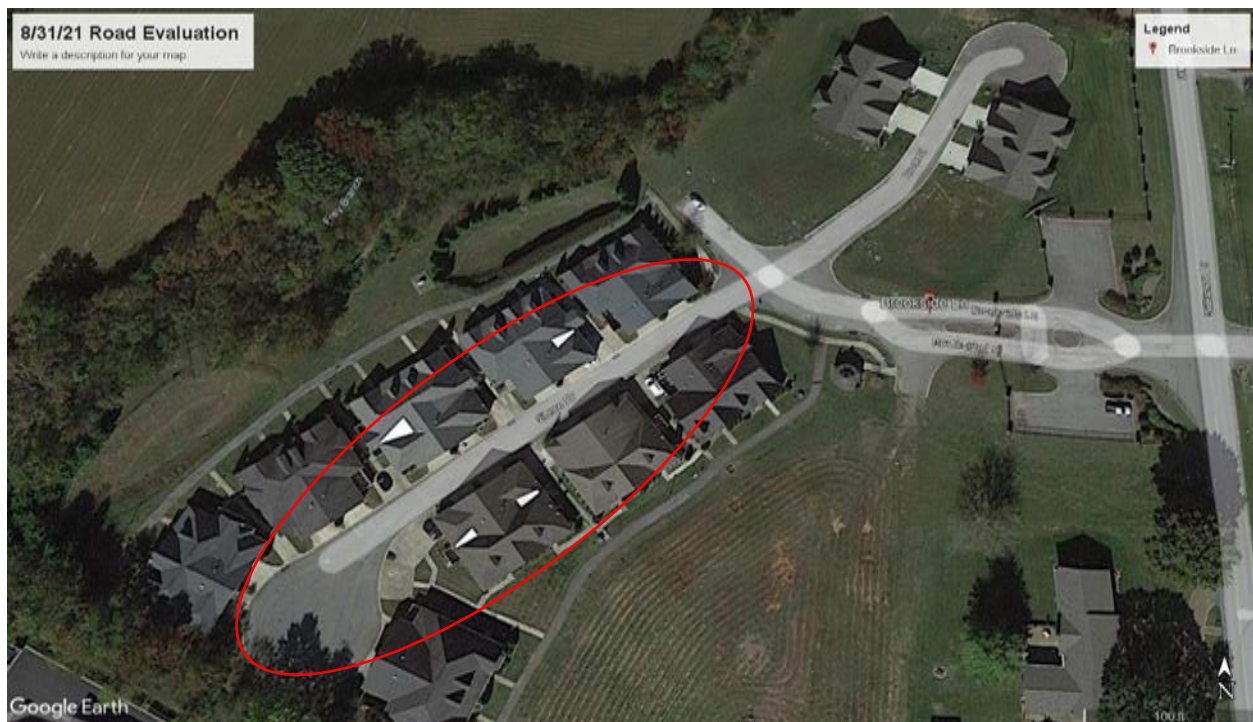
**Alligator cracking:** Is a load associated structural failure. The failure can be due to weakness in the surface, base or sub grade; a surface or base that is too thin; poor drainage or the combination of all three. It often starts in the wheel path as longitudinal cracking and ends up as alligator cracking after severe distress. The cul-de-sac does meet the turn radius for the fire department.

**Shoving:** Shoving is the formation of ripples across a pavement. This characteristic shape is why this type of distress is sometimes called wash-boarding. Shoving occurs at locations having severe horizontal stresses, such as intersections. It is typically caused by: excess asphalt; too much fine aggregate; rounded aggregate; too soft an asphalt; or a weak granular base.

**Grass** – Poorly maintained roads will often have grass growing up through the cracks. Cleaning the cracks should be standard practice before sealing them. Use a heat lance to burn out the crack and/or blow out the cracks depending on the severity of the problem.

**FIX:** Because a structural failure is taking place the only possible solution to alligator cracking is to perform a full-depth patch.

**FIX:** Partial or full depth patch
