City of White House, Tennessee
American with Disabilities Act
Facilities Inventory Self-Evaluation and Transition Plan

CSR
Engineering

November 30, 2019

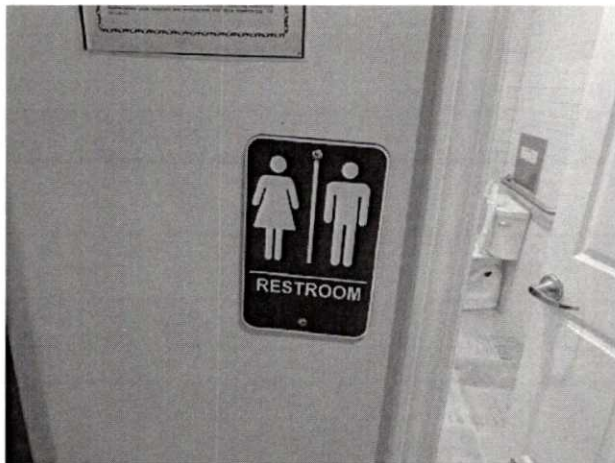
WH Inn Museum-Restroom Sign Non-Compliant

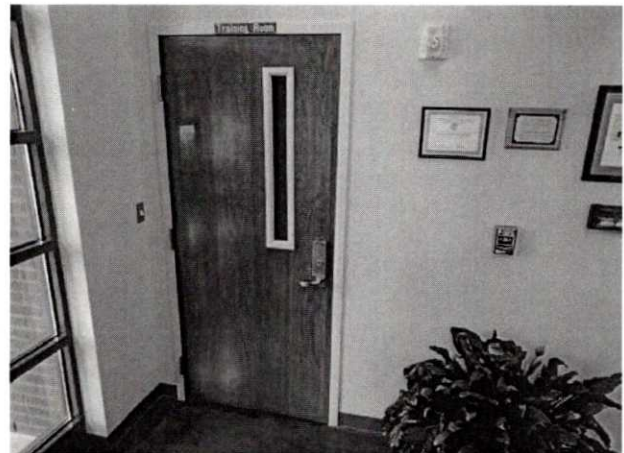
Fire Station #2-Training Room Sign Non-Compliant

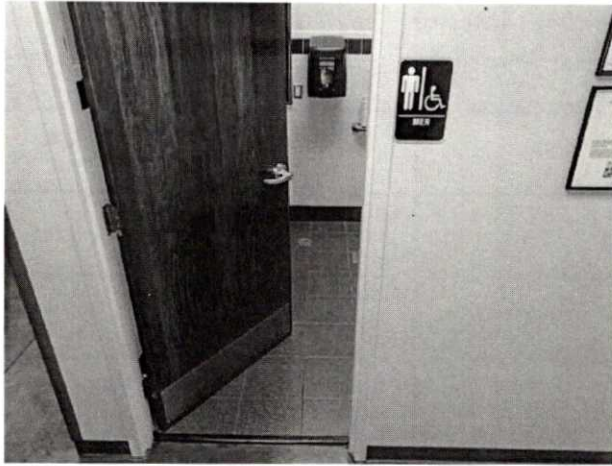
Fire Station #2-Restroom Door Not Self-Closing

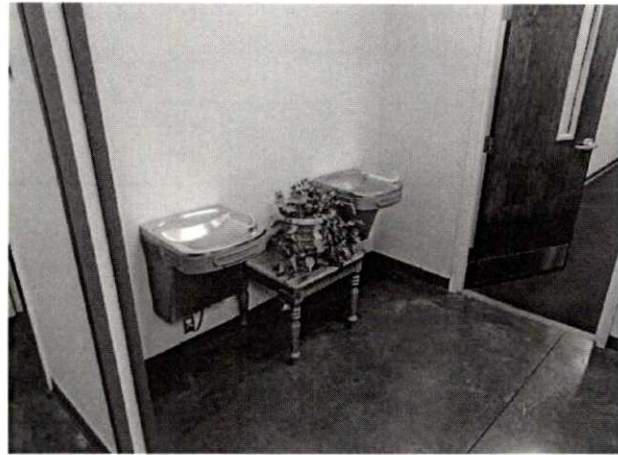
Fire Station #2-Water Fountains Non-Compliant

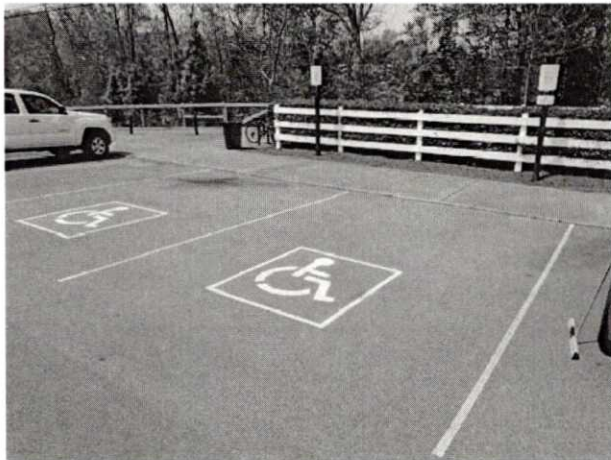
Tyree Springs Trailhead-No accessible Aisle or Ramp

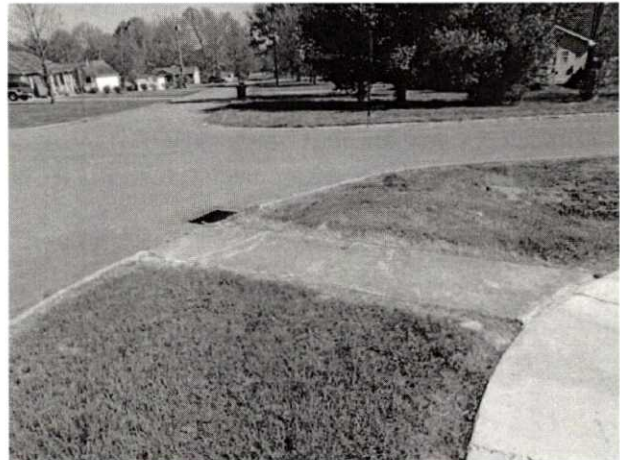
North Woods Park-No Accessible Parking

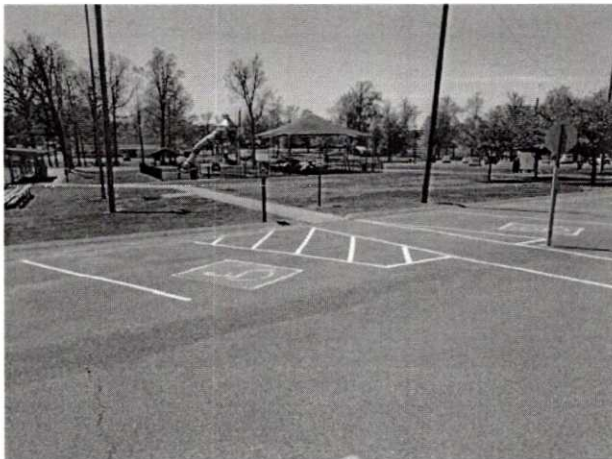
WH Mun. Park-Play Area, Non-Compliant Aisle and Signage

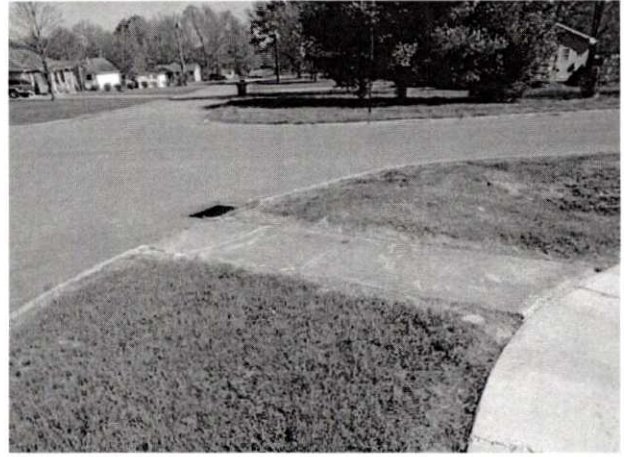
North Wood Park-Ramp Not Compliant

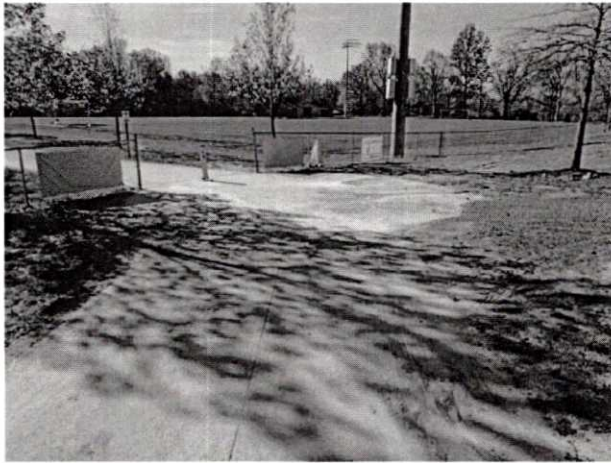
W.L. Anderson Sports Complex-Sidewalk Maintenance

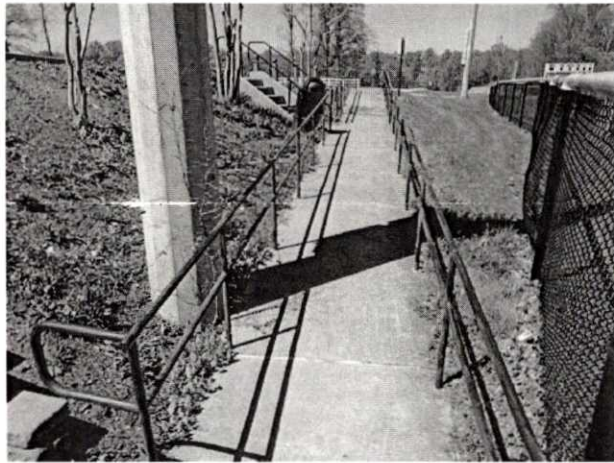
Sidewalk to Field No. 7	Ramp down to field/bleachers has excessive slope and length
	Sidewalk to Fields Nos. 5 & 6	Excessive running & cross slopes; no railing over ditch crossing; no accessible path to bleachers & playing fields
	Sidewalk from Greenway to Dog Park	Running slopes exceed 8.3% at drainage culvert

WH Mun. Park-Ramp to Field #7 Exceeds Slope/Length

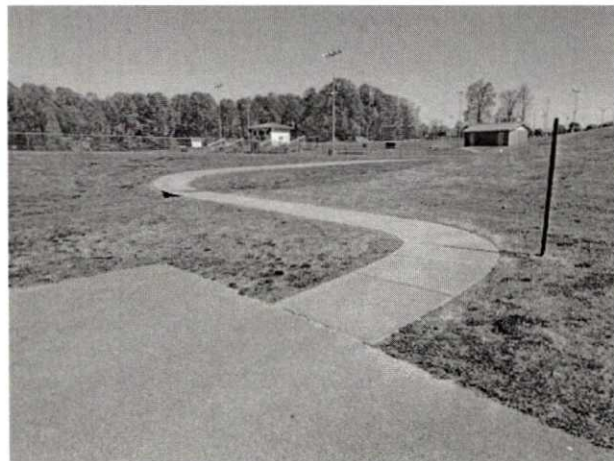
WH Mun. Park-Path to Fields 5 & 6-Exceeds Slope, No Rail over Ditch Crossing, No Path to Bleachers and Fields

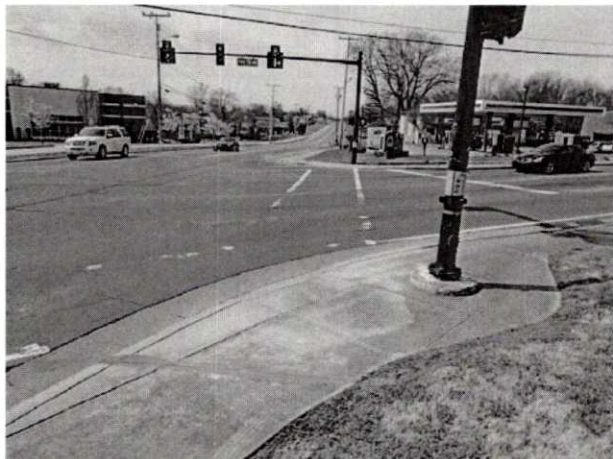
The Intersection (#6) at US 31W and SR 76 represents a major pedestrian crossing corridor. Each of the four corners has two crossings with pole mounted pedestrian signals. It is anticipated that the ongoing improvements along SR 76 will incorporate this intersection. The photos and table below present current observations and findings.

US 31W/SR 76 Crossing 4 Facing 3 (Note Pole in Path)

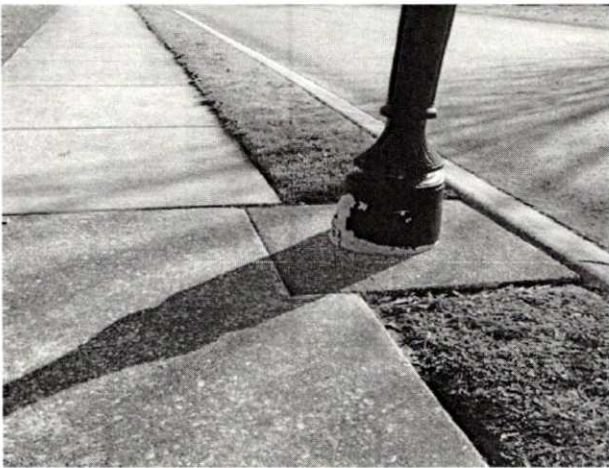
Sundance Way-Light Pole Base Discontinuity
