City of White House, Tennessee
American with Disabilities Act
Facilities Inventory Self-Evaluation and Transition Plan

CSR
Engineering

November 30, 2019

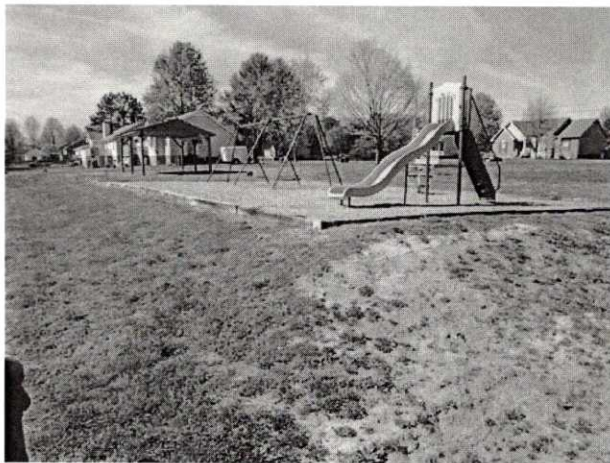
North Wood-Non Accessible Play Area

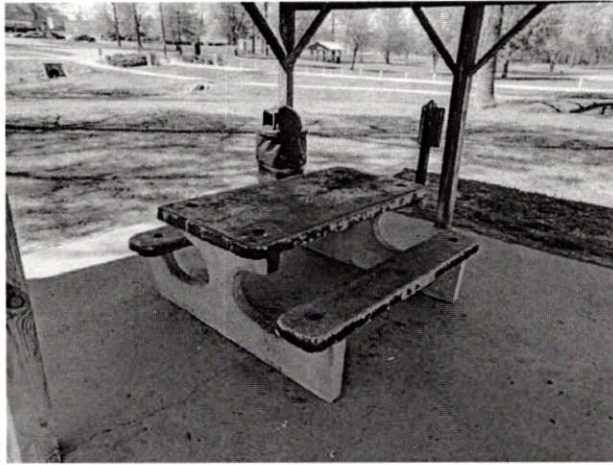
WH Mun. Park-Pavilion #2 Non-Accessible Picnic

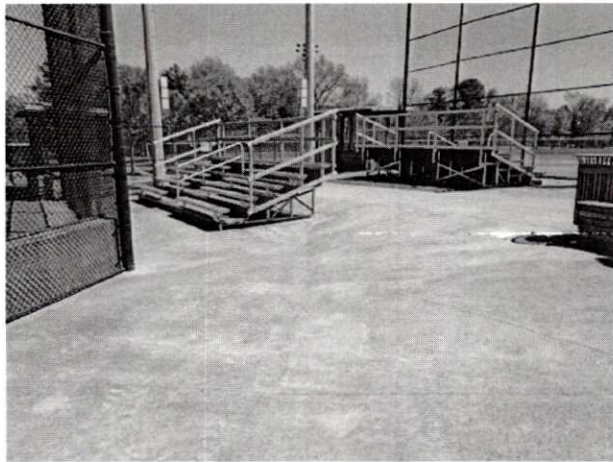
WH Mun. Park-Typical Bleachers Non-Accessible

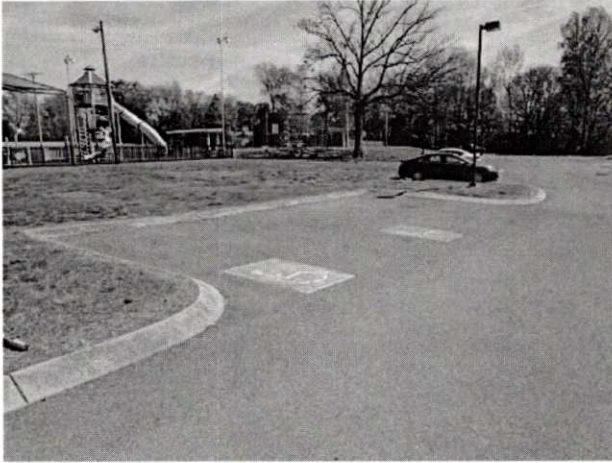
WH Mun. Park-faded Paint, No Signage

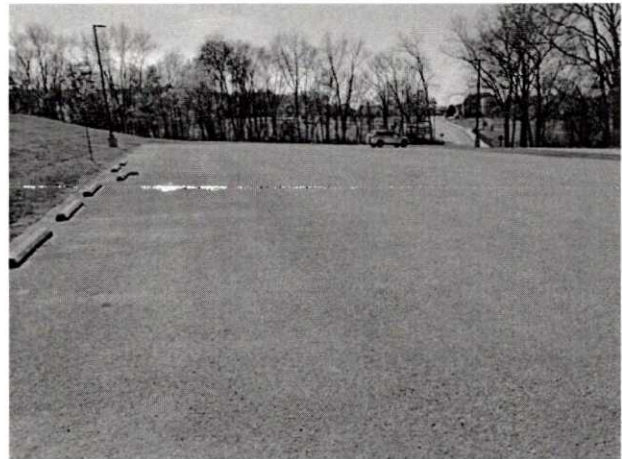
WH Mun. Park-Fields 5-6; No Accessible Spaces

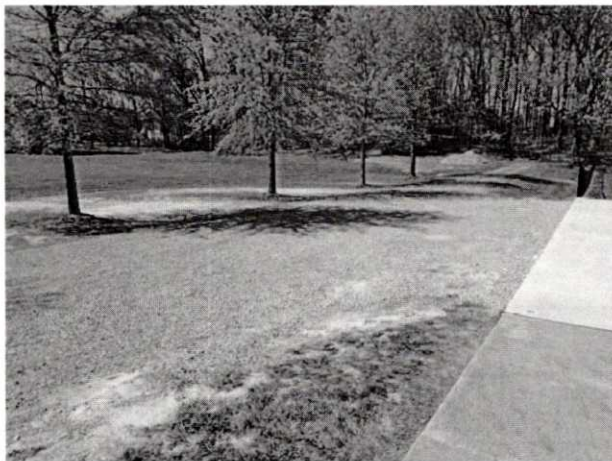
WH Mun. Park-Dog Park; No Accessible Spaces

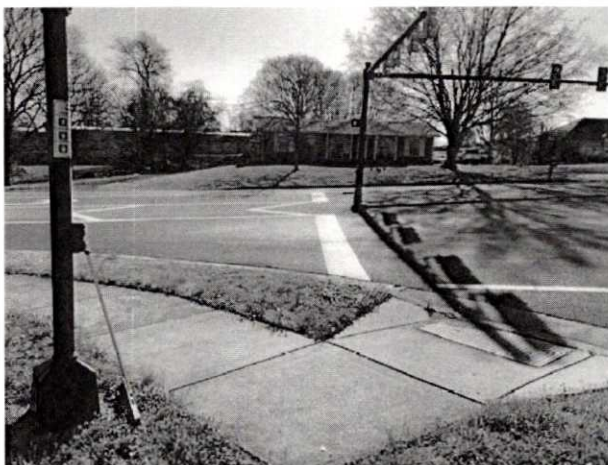
Wilkinson-Richard Wilks Crossing 4 facing 1

Pedestrian signals and crossings at the Wilkinson Lane and Richard Wilks intersection (#3) have been installed with future improvements in mind. For example, new signal poles and equipment have been installed at all four corners, however, presently there is only one crossing available.

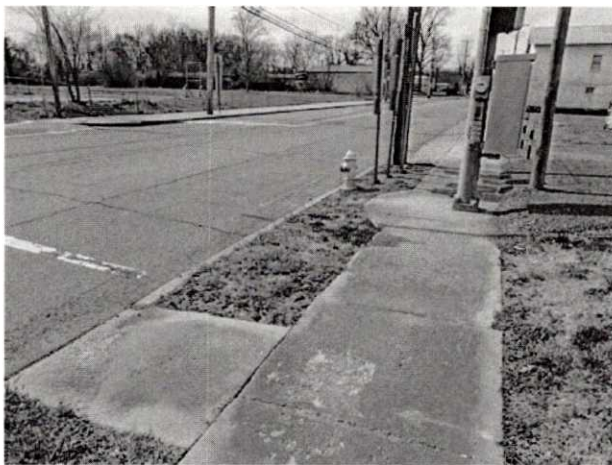
US 31W & Portland Rd: Corner 3

The intersection (#7) at US 31W and Portland Road is in need of improvements and upgrades. The signal pole at corner 1 is located in the pedestrian path, signals are not working, push buttons are not in compliance, signs direct to wrong direction and crosswalk paint is faded. The photos and table below present current observations and findings.

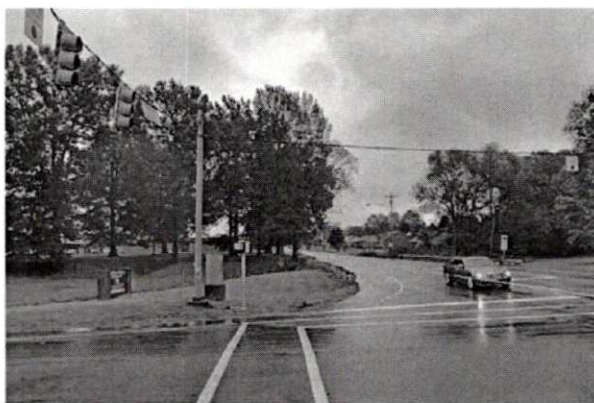
Hirsch/Tyree Springs: Crossing 4 to 1

The intersection (#8) at Raymond Hirsch and Tyree Springs Road in need of improvements and upgrades. Signal crossing poles are located on all four corners, however the intersection has not been improved with sidewalks and accessible pathways. It is assumed that the crosswalks and signals are for students walking to nearby White House High School and to control School traffic. There are no sidewalks, no clear path to pushbuttons, out of compliance push buttons, non-working crossing signs and a guardrail impedance. The photos and table below present current observations and findings.
